INVESTIGATION

Bryson Crash

RFI#22SC0121

INVESTIGATION OF THE BRYSON CRASH**EXPERT'S SUPPLEMENTAL REPORT****JUNE 14, 2024****A. INTRODUCTION**

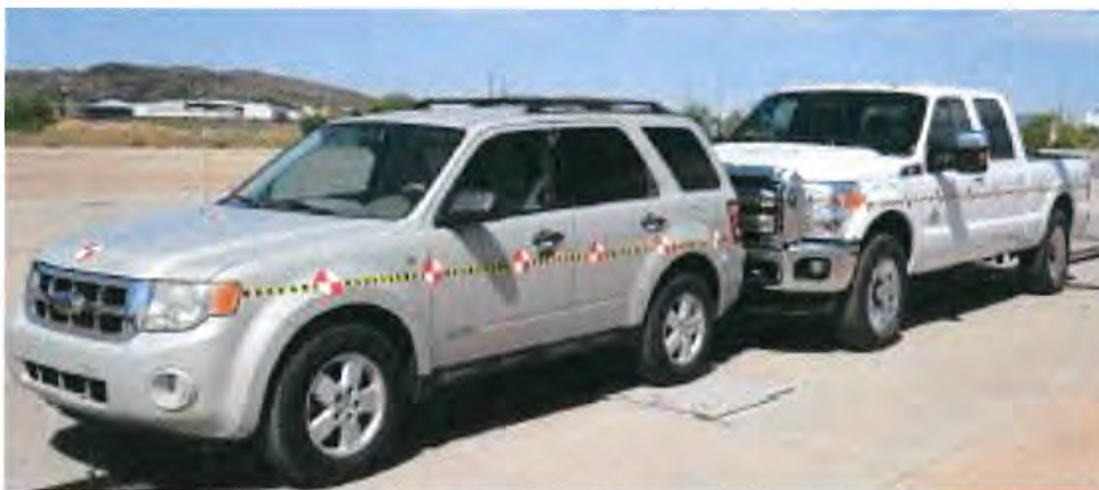
Image 1: Pre-Test Vehicle Condition

Both vehicles were ballasted, instrumented and the impact velocity of the F-250 was reported as 49.9mph with the test set up so that the front of the F-250 struck the rear of the Escape. The Escape was positioned to the right of the F-250 (and the test guide rail centerline) with an offset of about 10.8". To date, there has been no opportunity to inspect the tested vehicles. Image 1 shows the pre-test impact configuration.

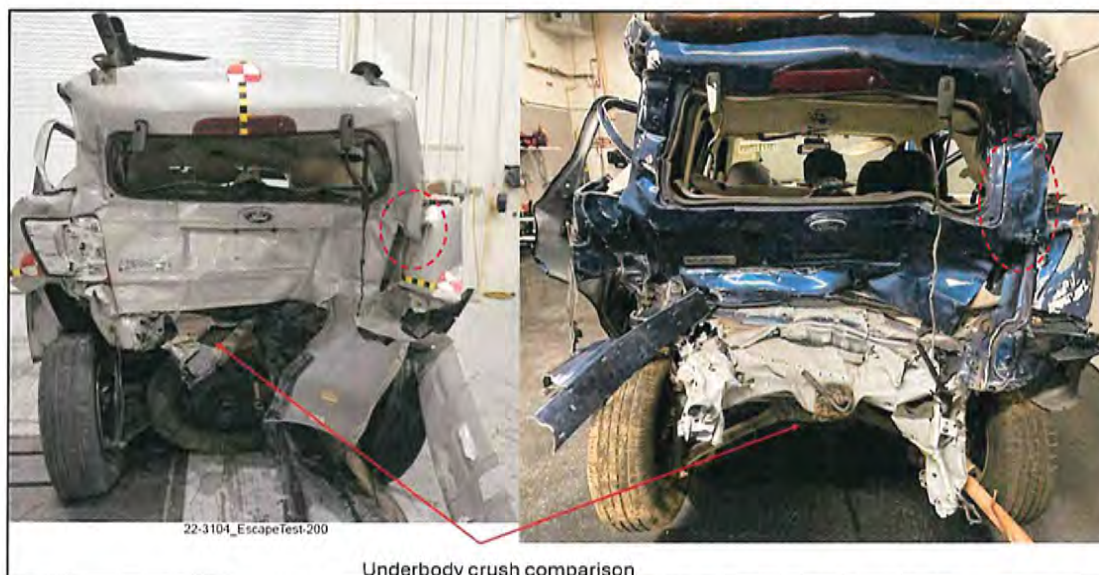
Image 2: Deformed Escape Comparison – Rear View

12. The tested Escape exhibited significantly increased underbody deformation than the subject Escape – Image 2 shows a comparison of the two vehicles, with the tested Escape on the left and the subject vehicle on the right. The tested Escape's underbody has been deformed, the rear rails are not exposed, and the rear floor is not visible. There was vertical alignment of the vehicle energy absorbing structures in the test.

13. The lateral vehicle overlap in the test does not match the subject condition. Image 2 shows that the right side of the subject liftgate pillar exhibits direct contact deformation (circled), whereas the tested Escape exhibits induced damage, or non-direct deformation. This indicates that the alignment of the vehicles was further offset in the test than the subject crash, resulting in less lateral overlap and therefore less structural engagement in the crash test.

Additionally, the crash test overlap and setup are unrepresentative of the subject crash. The overlap between the two vehicles was additionally offset by at least 4" based on the deformation pattern of the liftgate and the width of this structure, resulting in less lateral engagement in the crash test than the subject test. Less lateral engagement results in the impact being concentrated on a smaller area of the Escape. It is possible that the guidance system used for the F-250 was unable to maintain the test setup

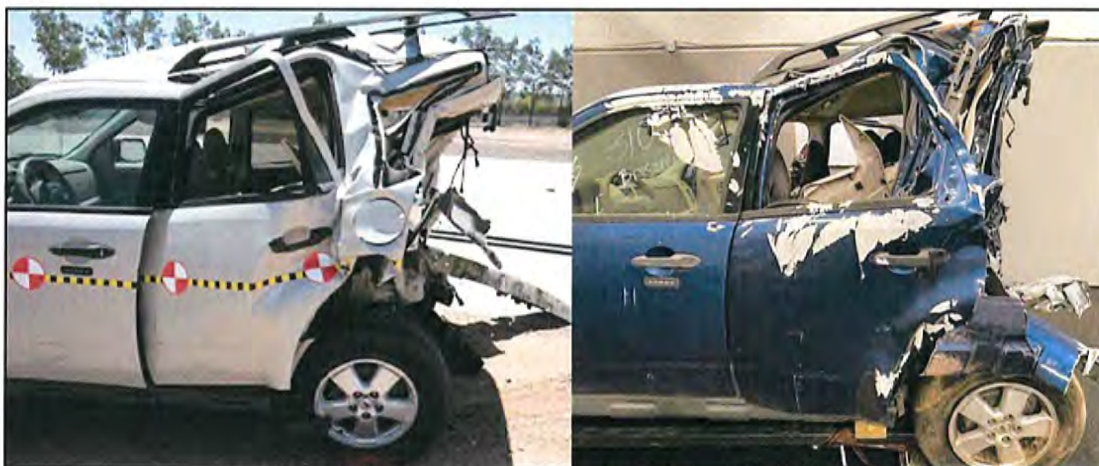
Image 3: Deformed Escape Comparison – Left Side View

14. The tested Escape exhibited less deformation on the left bodyside rearward of the rear door than the subject Escape – Image 3 shows a comparison of the two vehicles, with the tested Escape on the left and the subject vehicle on the right. The tested Escape's C pillar is still visible, and the fuel filler door undeformed whereas the subject Escape's C pillar has been deformed forward of the rear door's trailing edge. The crash tested Escape's roof is also less crushed.

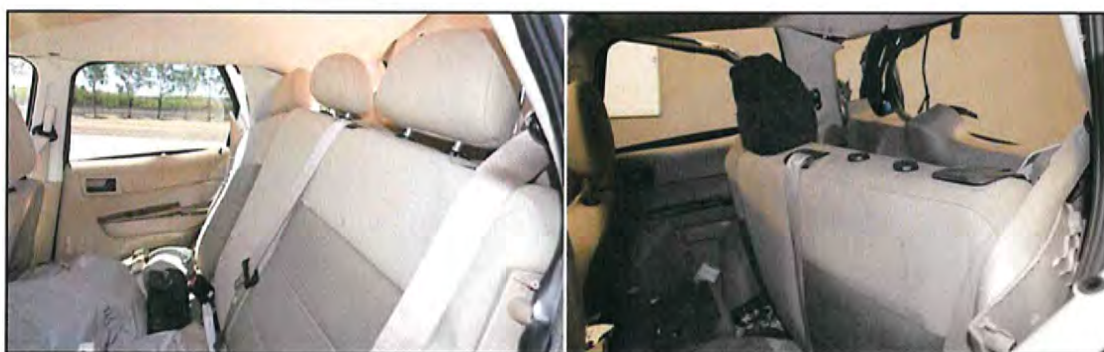
Image 5: Rear Seat Comparison

16. The tested Escape exhibited less rear seat static deformation (forward in vehicle) than the subject Escape – Image 5 shows a comparison of the two vehicles, with the tested Escape on the left and the subject vehicle on the right. The seat back angle is still rearward in the tested Escape, with the headrests adjacent to the C pillar. Whereas the subject Escape's seat back angle is forward, with the headrests significantly forward of the C pillar.

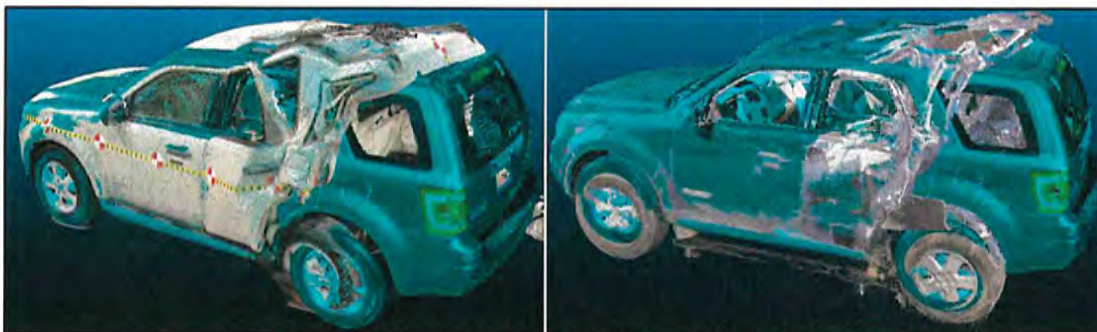
Image 6: Point Cloud Overlays

17. An analysis of overlaid laser scan point cloud data for an exemplar Escape with both the crash test Escape and the subject Escape (Image 6 – crash test on left, subject on right) identifies the following:
- The subject Escape's wheelbase (left side) was almost unchanged at 103".
 - The crash test Escape's wheelbase (left side) was reduced by about 5".
 - The subject Escape's static seat back angle changed from about 65° to the horizontal to greater than 90°, being rotated forward. See Image 7 with the subject Escape on the right.
 - The crash test Escape's static seat back angle (post-test) was largely unchanged from the pre-test condition. See Image 7 with the crash test Escape on the left.

Grimes did not conduct a detailed analysis of the structural intrusions or the rear seat static movement between the crash test and subject crash. His only intrusion analysis consisted of an overlay of the point cloud data of the two sets of vehicles, and he opined that the crash test intrusion was higher than the subject crash intrusion. He did not study the intrusion related to the second-row survival space. If the crash test intrusions were higher than the subject crash, this would be unusual and contrary to known compatibility testing data and published reports. In Ford's compatibility research (Roche 1st supplemental report) the intrusions were increased with the truck's ride height being increased. In NHTSA's compatibility testing¹ there was a reduction of intrusion by about 5" when a 2006 Ford F-250s with a Blocker beam (SEAS) was crashed into 2002 Ford Focus compared to a F-250 without a Blocker beam. The addition of the SEAS resulted in more structural compatibility and reduced the intrusion in the struck vehicle. The Exponent crash test intrusion increase is likely due to the test setup, including the vehicle ballasting, vehicle overlap and possible park brake engagement of the Escape.
